# WESTBURY HOUSE, EAST MEON, HAMPSHIRE

HERITAGE APPRAISAL

An assessment of the heritage significance of  
Westbury House, East Meon, Hampshire

FORUM  
Heritage  
Services

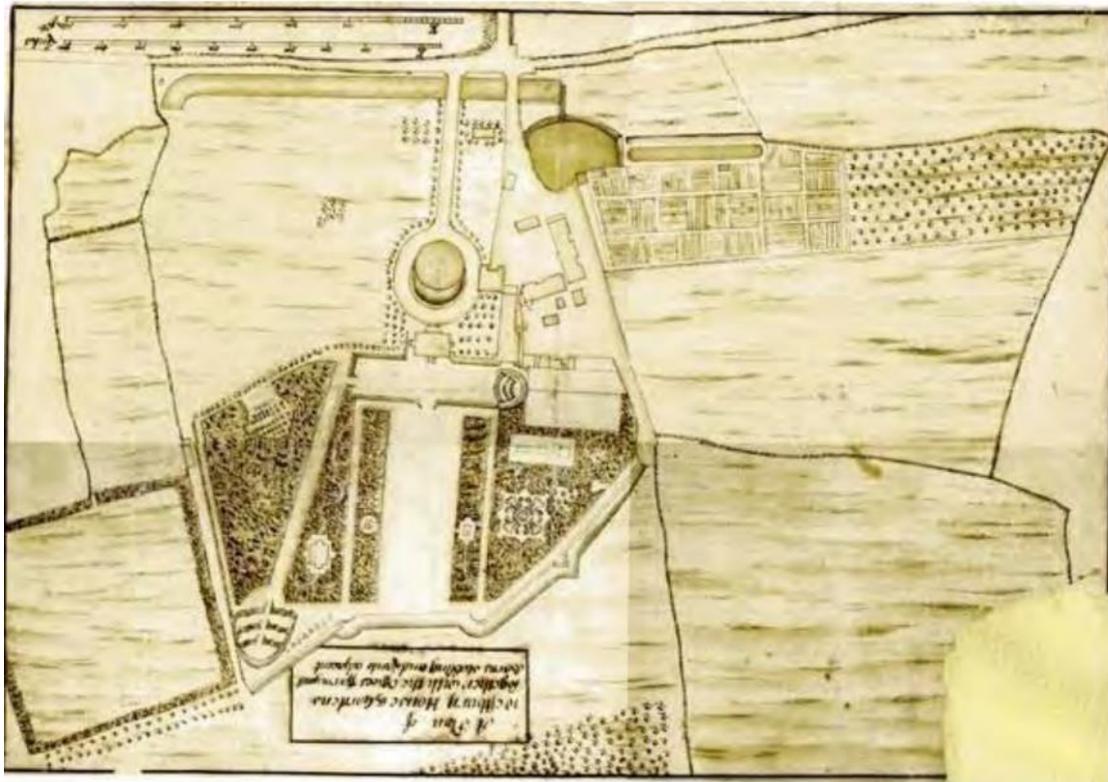
Figure 1: Survey plan by Charles Bridgeman c1720 for Admiral Philip Cavendish.

- 3.17 A survey plan c1720 prepared by Charles Bridgeman (**Figure 1 Appendix B**) appears to be the earliest cartographic record of the house and its grounds. It shows the extent of planned landscaping around the 18<sup>th</sup> century mansion. Of particular note is the stable block and kitchen garden appear to be in place by this time. The access is via a straight approach from the north which passes adjacent to the chapel of St Nicholas. One of the two bodies of water present on the site can be seen.
- 3.18 The West Meon tithe map of 1839 (**Figure 2 Appendix B**) shows the serpentine lake of Bridgeman's plan to the north but not the grand approach from the north. Rather a long circuitous route from the west at the junction of West Meon Road and Coombe Lane runs up to the house, no doubt to enjoy the full setting of the house on approach within its landscaped

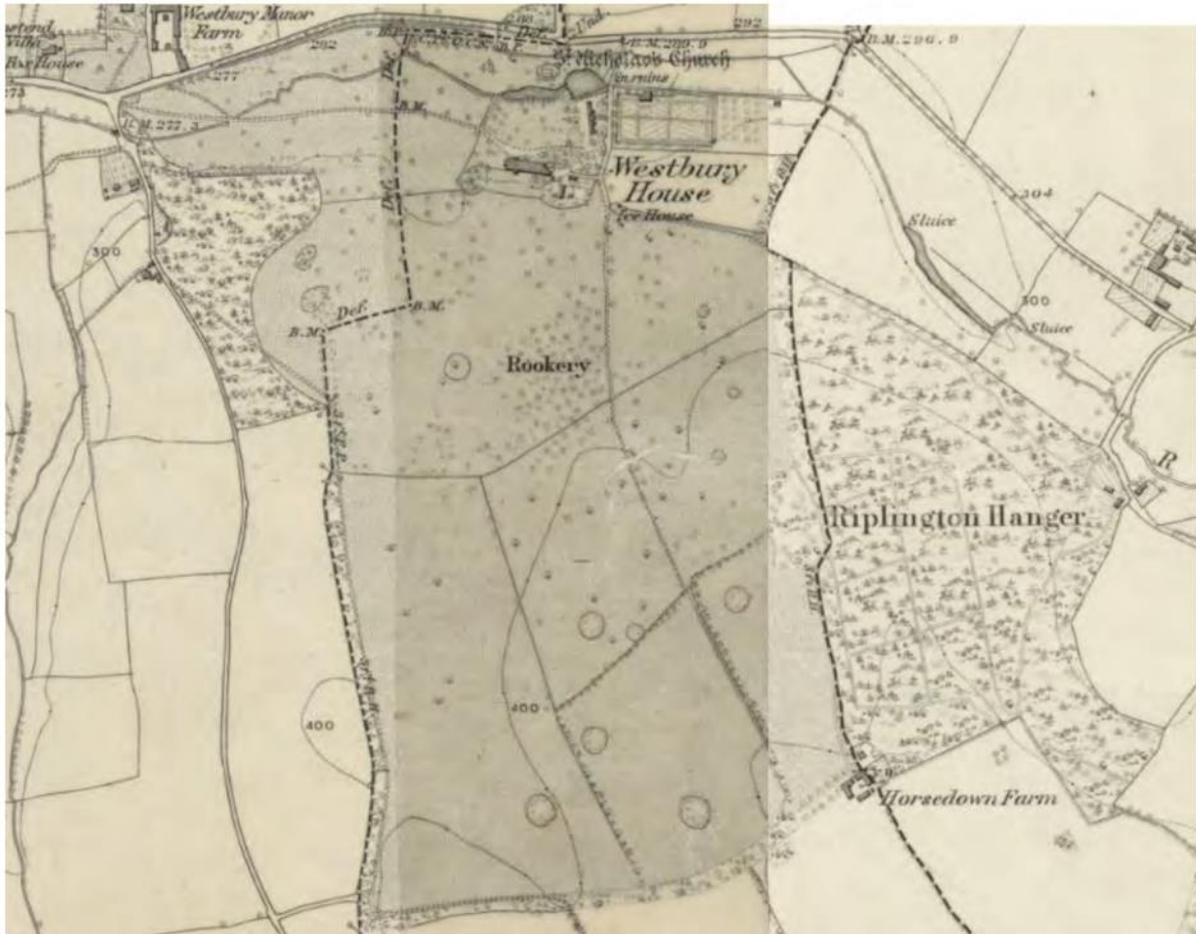
Figure 3: Ordnance Survey 6-inch map of 1869-70

- 3.19 The Ordnance Survey six inch mapping 1869-70 (**Figure 3 Appendix B**) provides a sense of the extent of the parkland associated with the house. The kitchen garden to the north-east is seen as well-established by this time. It is notable that the chapel of St Nicholas at this time is recorded as 'in ruins' by this date (see **Figure 4 Appendix B**).

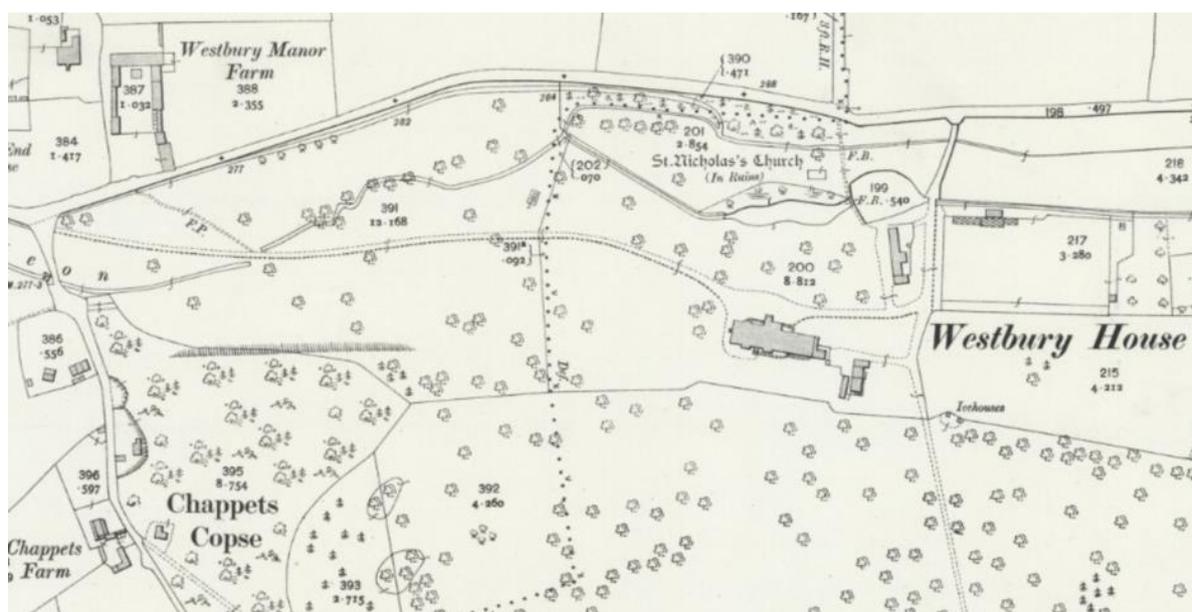
Figure 6: Ordnance Survey 25-inch map of 1909

- 3.21 The six inch and 25 inch Ordnance Survey mapping of 1909 (**Figures 5 and 6 Appendix B**) show the post-fire layout of the house and grounds. The double bays of the south (garden) side are clearly shown as is the extent of building which was retained post-fire running to the east from the main section of rebuilt house. There is an informal grouping of outbuildings to the east and south-east of the house, some of which survive today and were probably wood and fuel stores and buildings for the storage of equipment to maintain the gardens and grounds.

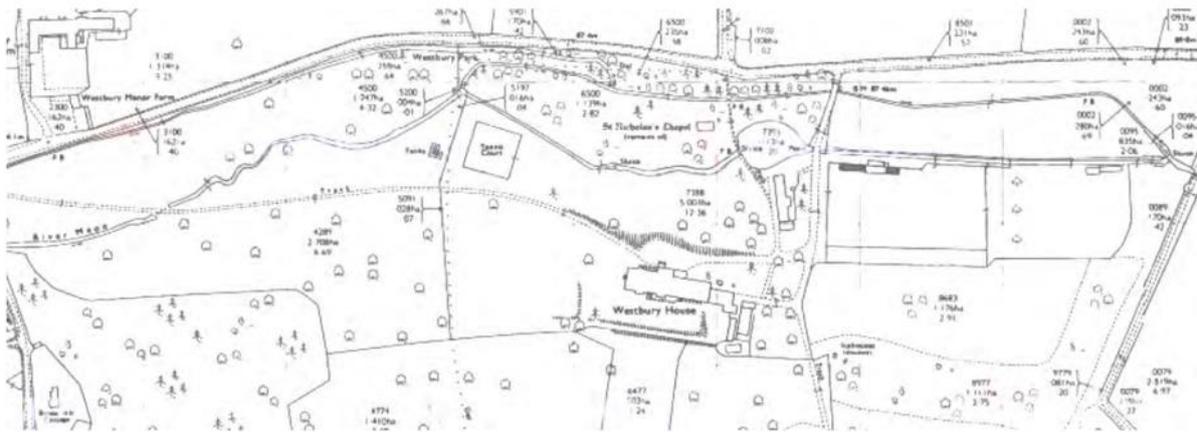
Figure 7: Ordnance Survey 25 inch map of 1972

- 3.22 The 25 inch Ordnance Survey mapping of 1972 (**Figure 7 Appendix B**) shows the school extensions to the building particularly to the east and south-east. And there is now a tennis court to the north-west. Of particular note is the loss of the serpentine lake.

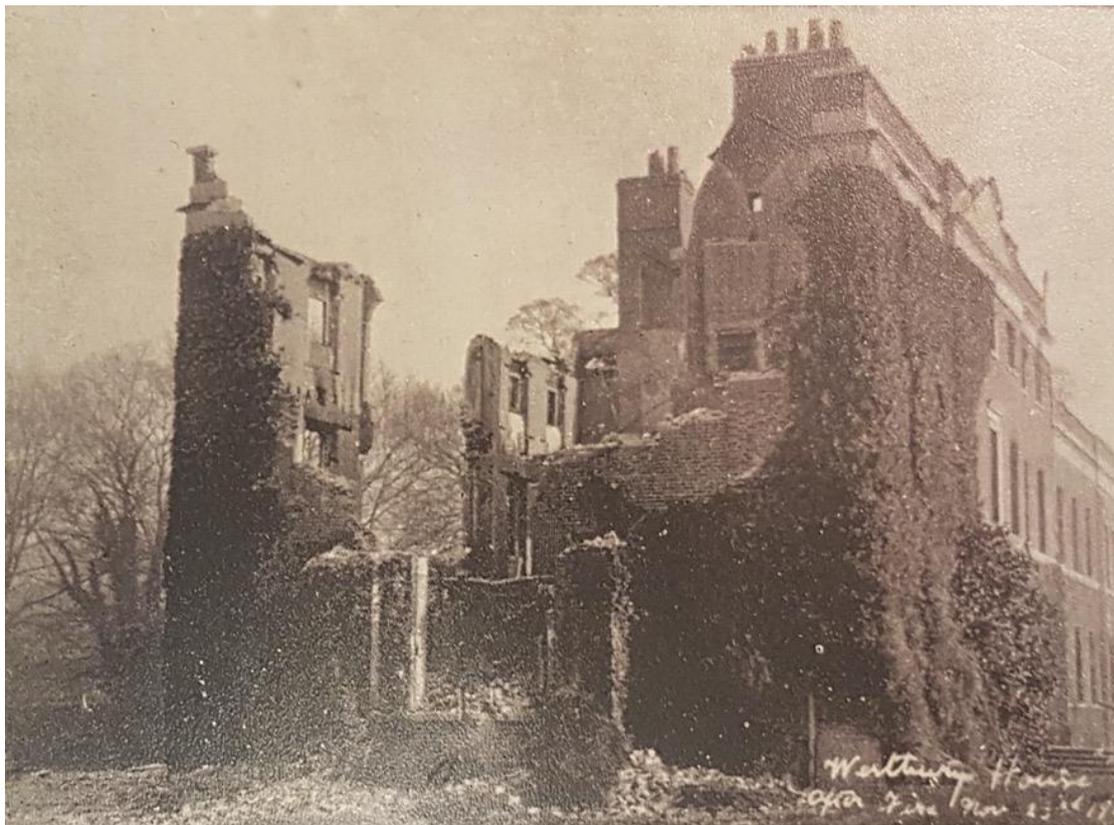
Figure 1: Westbury House immediate post-fire 1904 – west elevation (and part south)

- 3.20 There are some valuable immediate post-fire photographs (c1904) of Westbury House (**Figures 1 and 2 Appendix C**). These show the extent of damage with only part of the northern façade of the Georgian house surviving, none of the west elevation but all of the south façade. As can be subsequently seen in **Figure 3 Appendix C**, the decision was taken to completely demolish the existing principal Georgian building centred around the pediment and rebuild completely in the style and form seen presently. It is notable however that the Georgian wing to the east survived the fire and remains (in facades only) to this day.

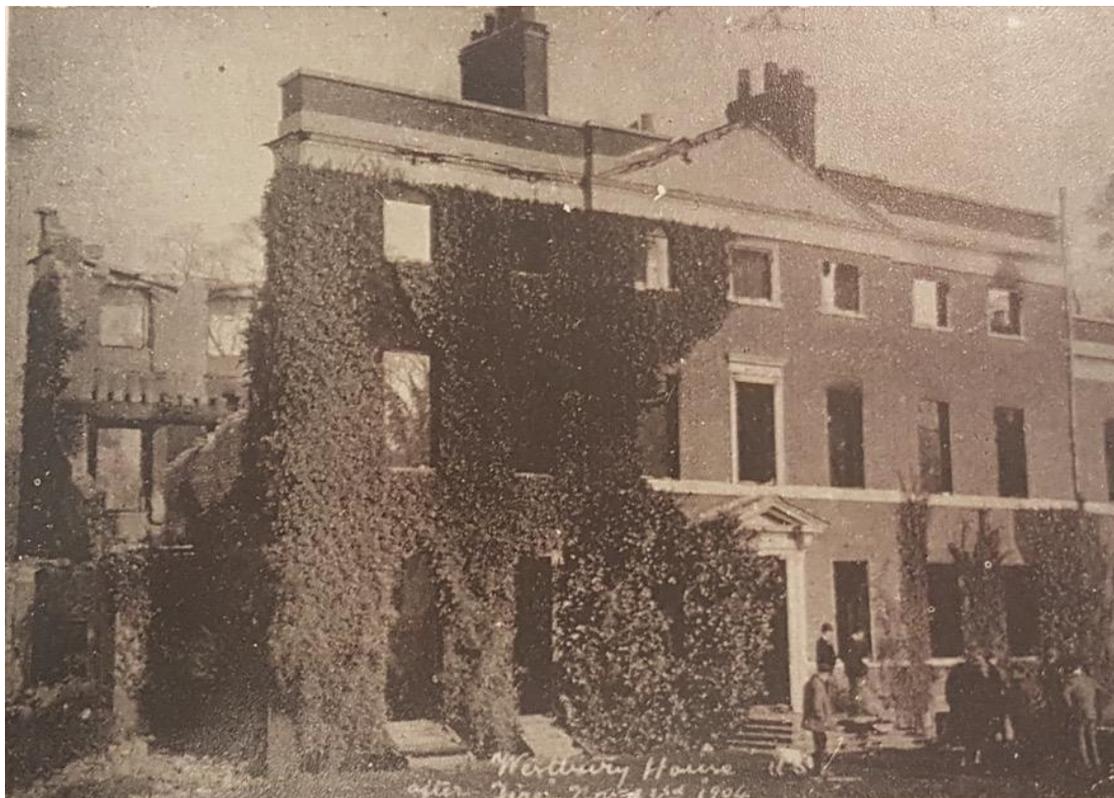
Figure 2: Westbury House immediate post-fire 1904 – South elevation

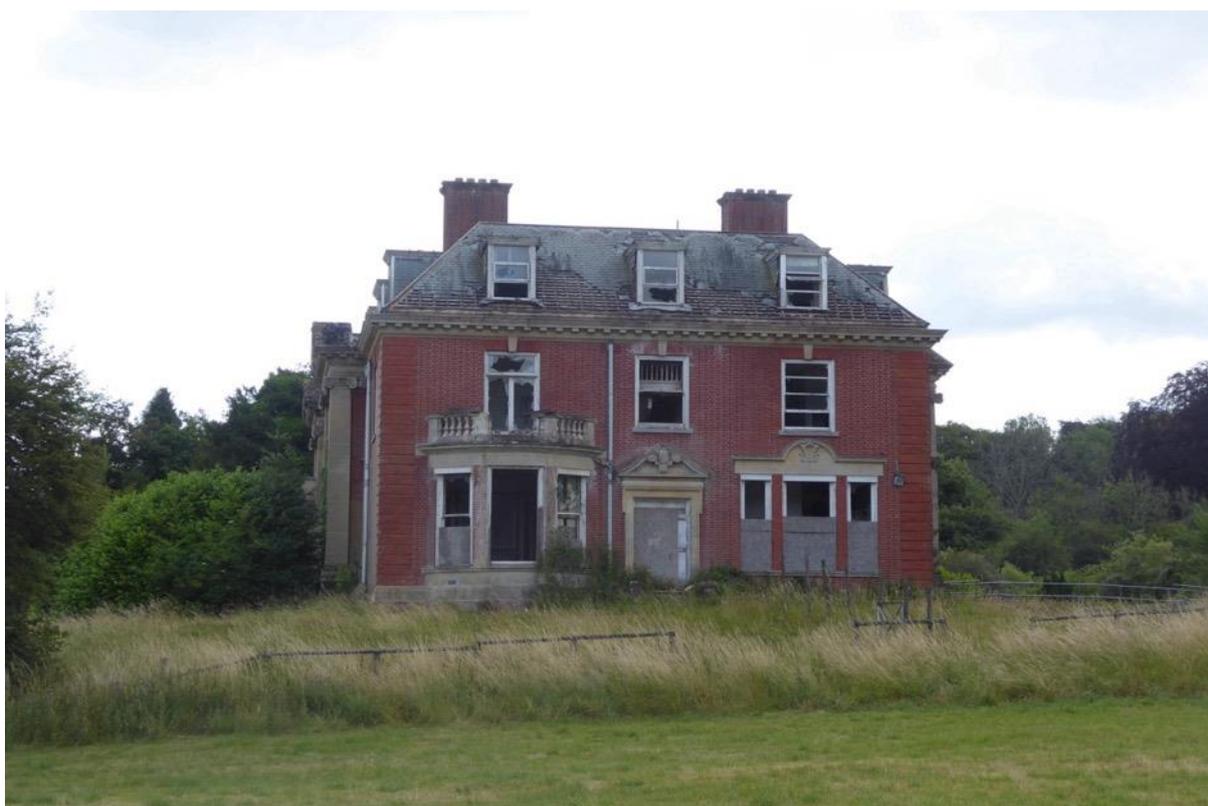
Figure 3: Westbury House – west elevation

Abutting the east end of the elevation is a narrow three-storey block with mullioned windows to the ground floor, a window of Serlian form to the first floor and a tripartite window above; the block, which bears little stylistic relationship to the main range, is topped by a balustraded parapet. On the northern (sic) elevation there are projecting bays (**Figure 2 Appendix D**), here with triangular pediments, and a central entrance with a segmental-headed doorcase. To the east is a bow window; there is another bow window placed asymmetrically in the west elevation (**Figure 3 Appendix D**).

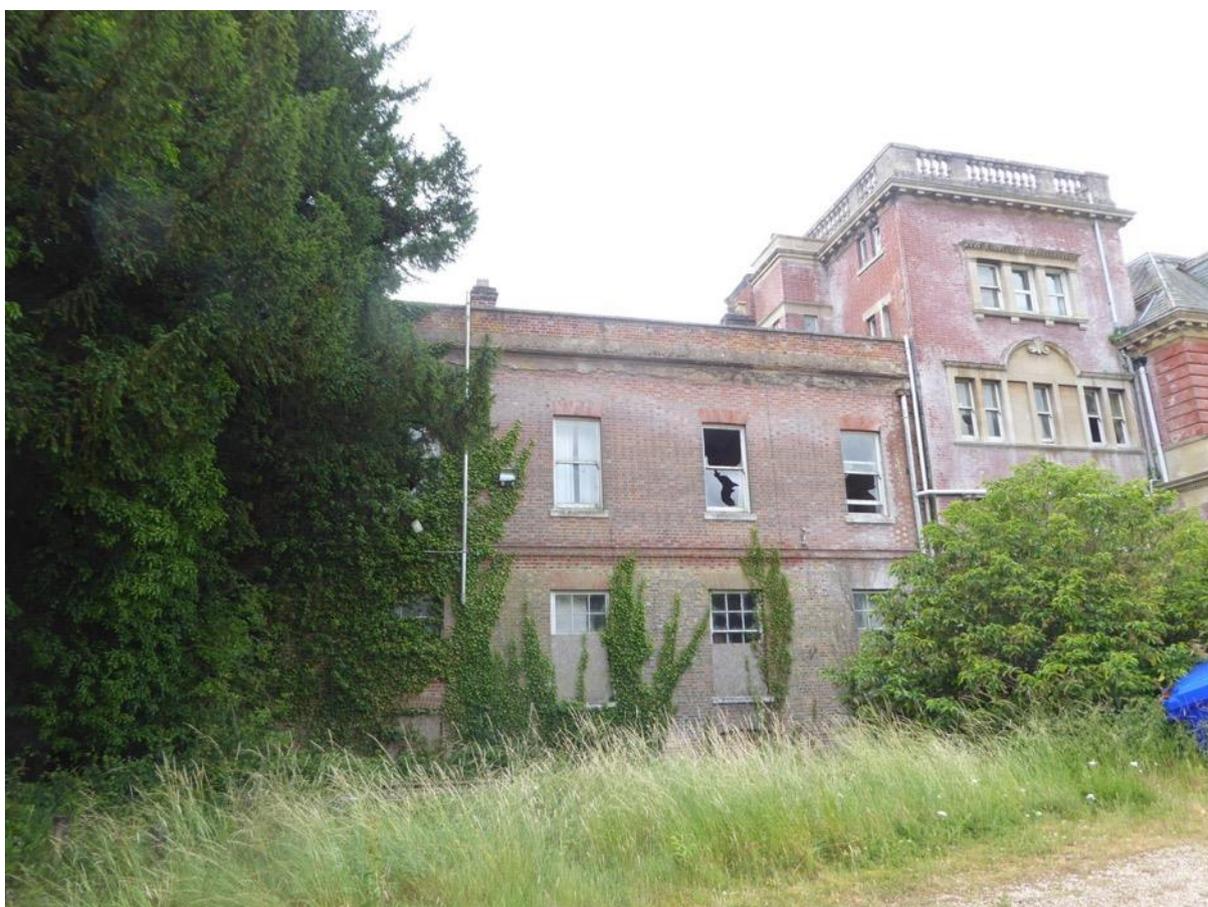
Figure 4: Late Georgian wing to the east of the 1904-6 reconstructed house

- 5.2 The description above does not include the additional wings to the 'main' house which extend east and comprise principally two storey with semi-basement in red brick (**Figure 4 Appendix D**). Repeated bays of sash windows in flat gauged brick arches. This section has a low 'M' roof in natural slate with central valley gutter and red brick chimney (**Figure 5 Appendix D**). There are two build-phases to this part of the house. The first five bays appear to date to the mid to late 18<sup>th</sup> century (**Figure 6 Appendix D**) with a remaining section comprising a mid-20<sup>th</sup> century extension in red brick. From historic photographs of the previous mansion immediately

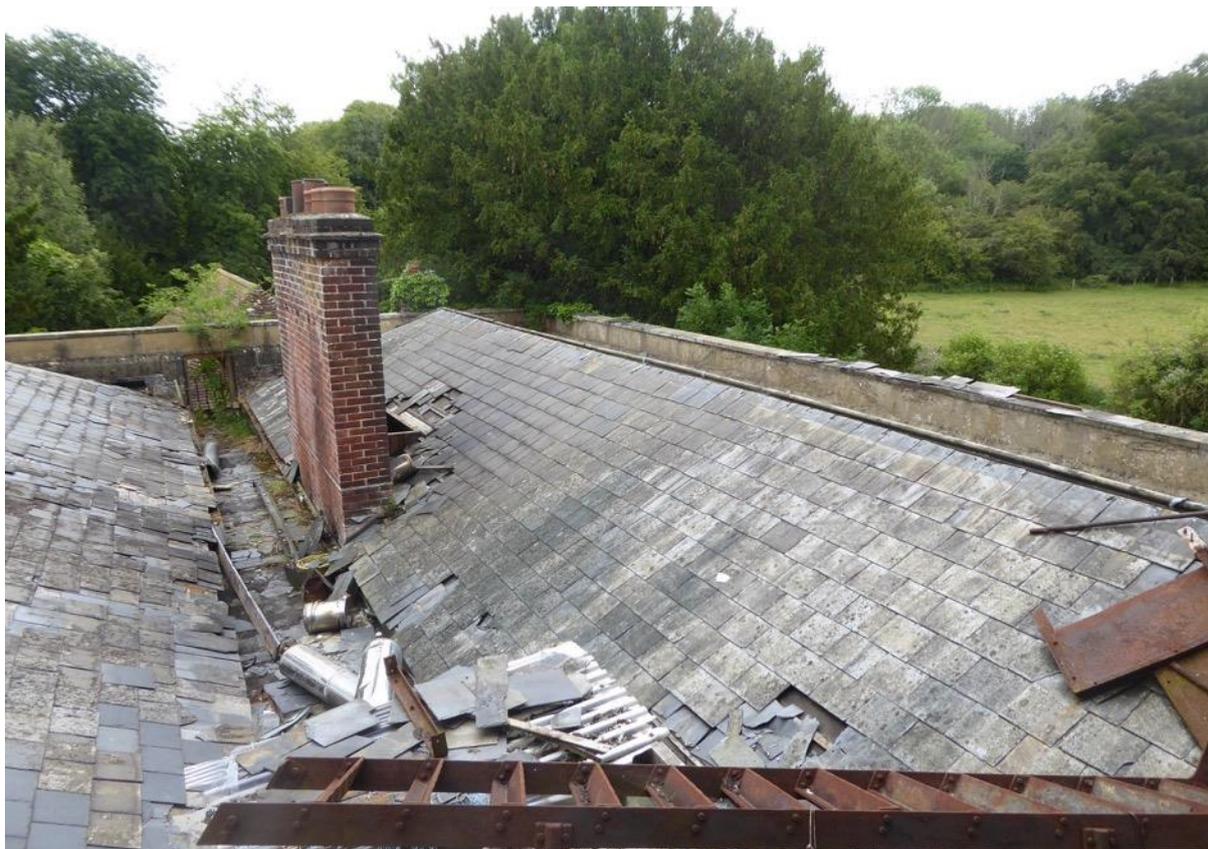
**Figure 5:** Roof of late Georgian extension

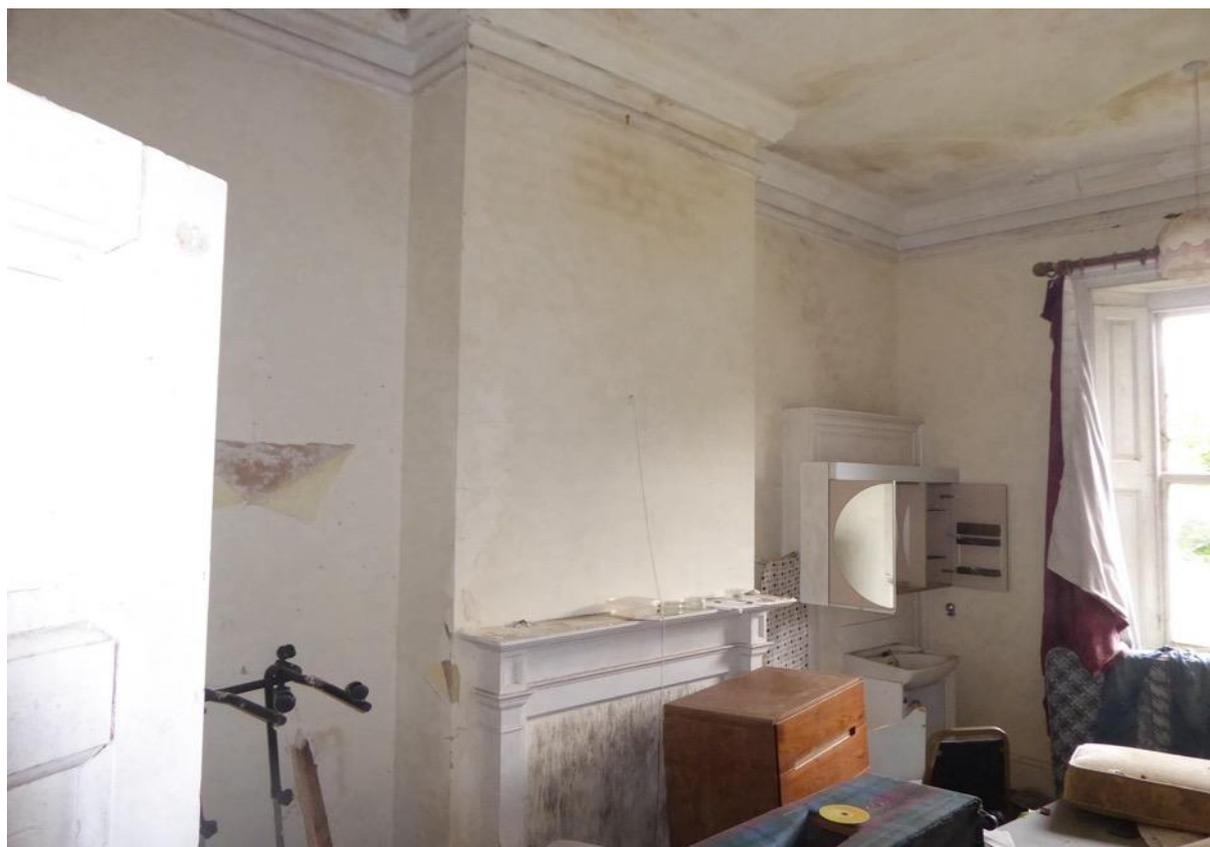
**Figure 7:** Relatively late internal finishes to the 18<sup>th</sup> century wing (probably dating from c1904-6)

post-fire and the present fixtures and finishes to these rooms (**Figure 7 Appendix D**) it would appear that the only elements to survive the fire were the walls to this part of the house. The remaining internal finishes are entirely contemporary with the reconstruction of the main house.

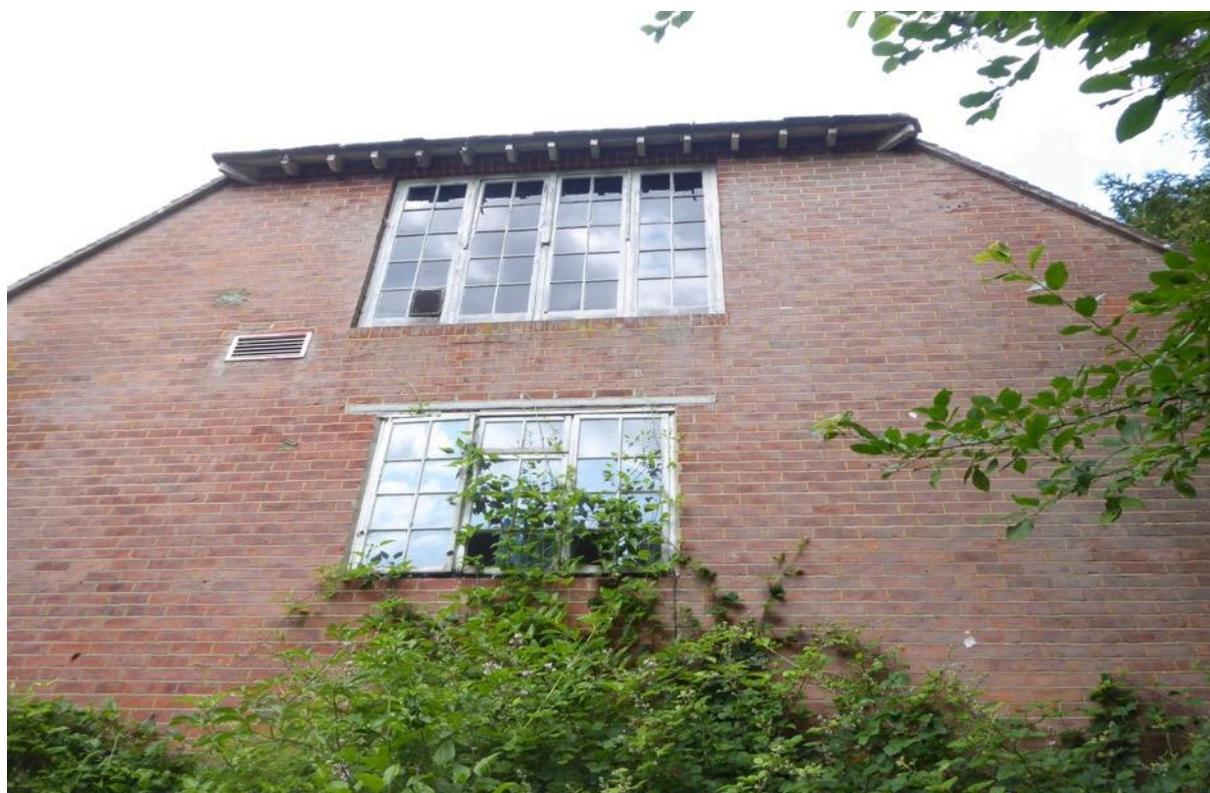
**Figure 8:** Late 20<sup>th</sup> century wing extension to the east – east elevation with large half-hip

- 5.3 To the east of this, there is a mid-20th-century School Dormitory Block with tiled roof, half-hipped at its east end (**Figure 8 Appendix D**). This links to a late-20th-century Care Home Linking Extension and Covered Courtyard, which joins the 'Power House' added in 1904-6 and subsequently converted to three bedrooms and a lounge during the period of care-home use.
- 5.4 Attached and to the north of the care house extension is a single-store brick and flint building under a tile roof, potentially of early-to-mid 19th-century date. This is referred historically as 'Former Boiler House'. Its last use appears to have been as a garden store (**Figure 9 Appendix D**). The structure semi-derelict with part of the roof collapsed into the building (**Figure 10 Appendix D**).

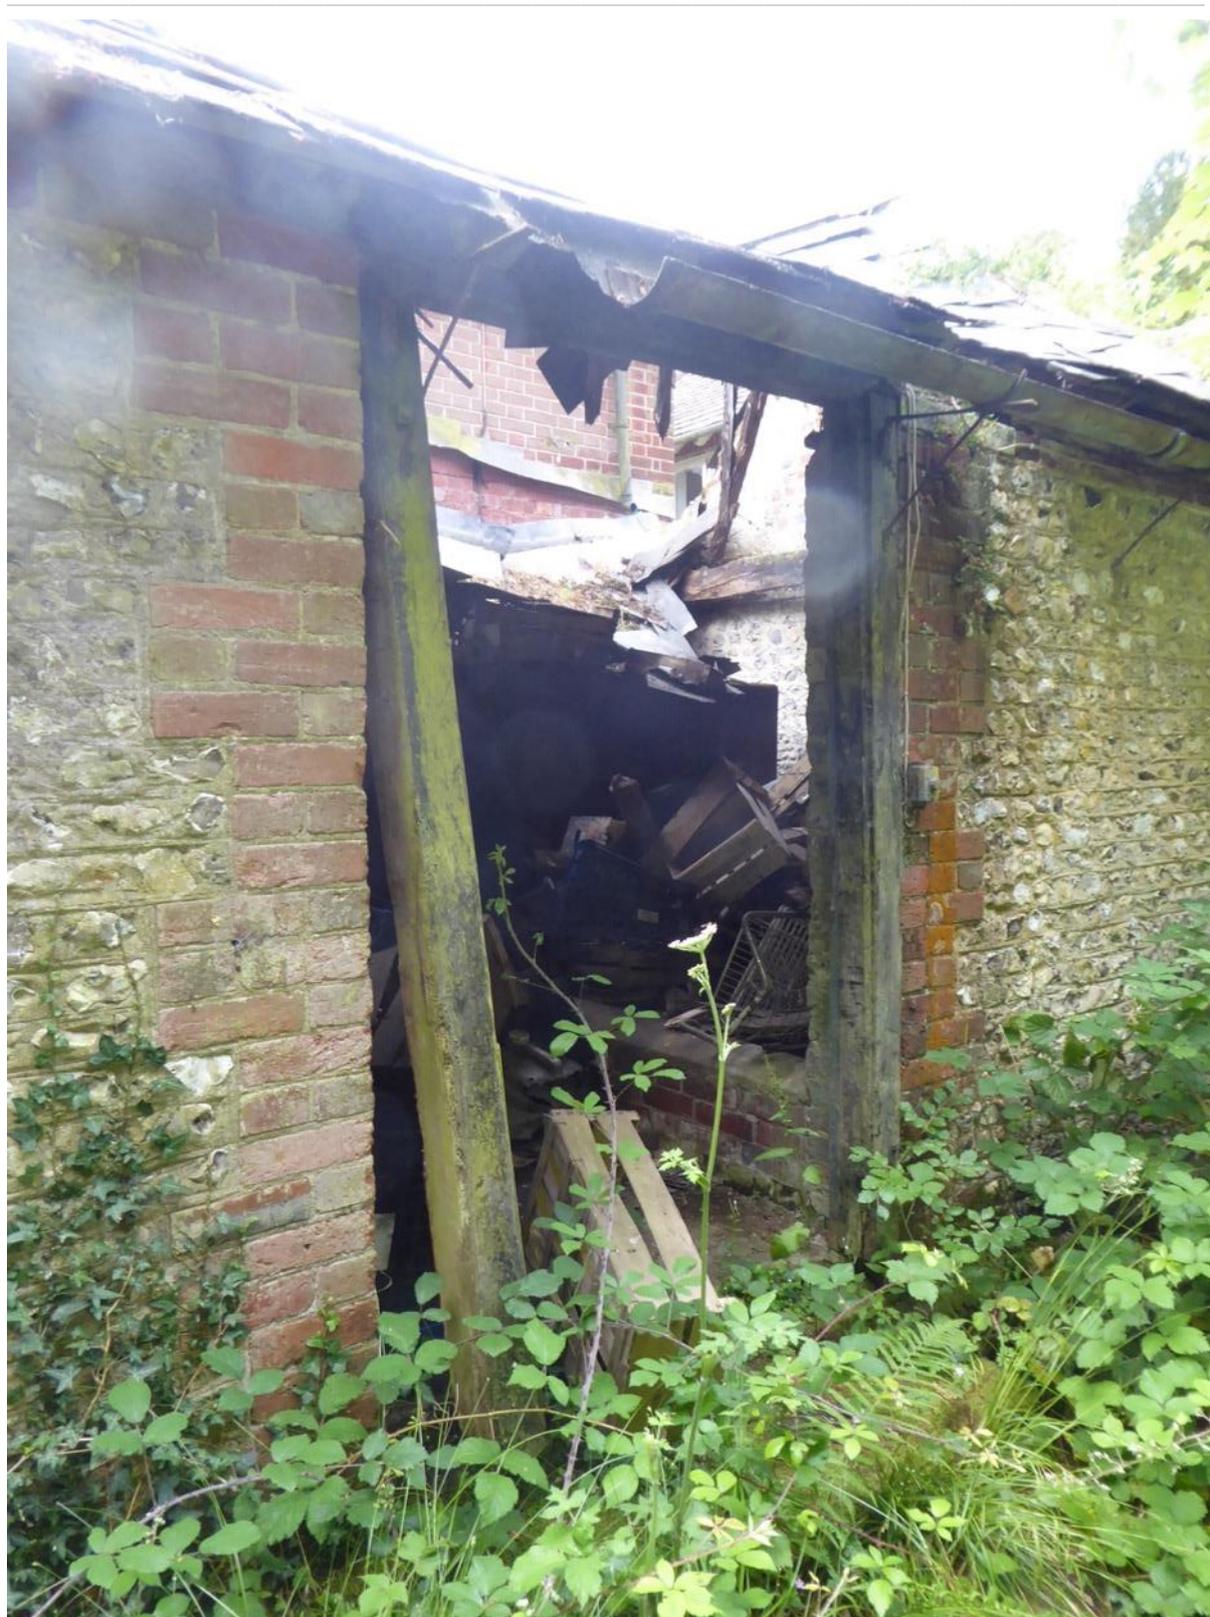
Figure 10: Partially collapsed roof of former 'boiler house' (to east of Westbury House)

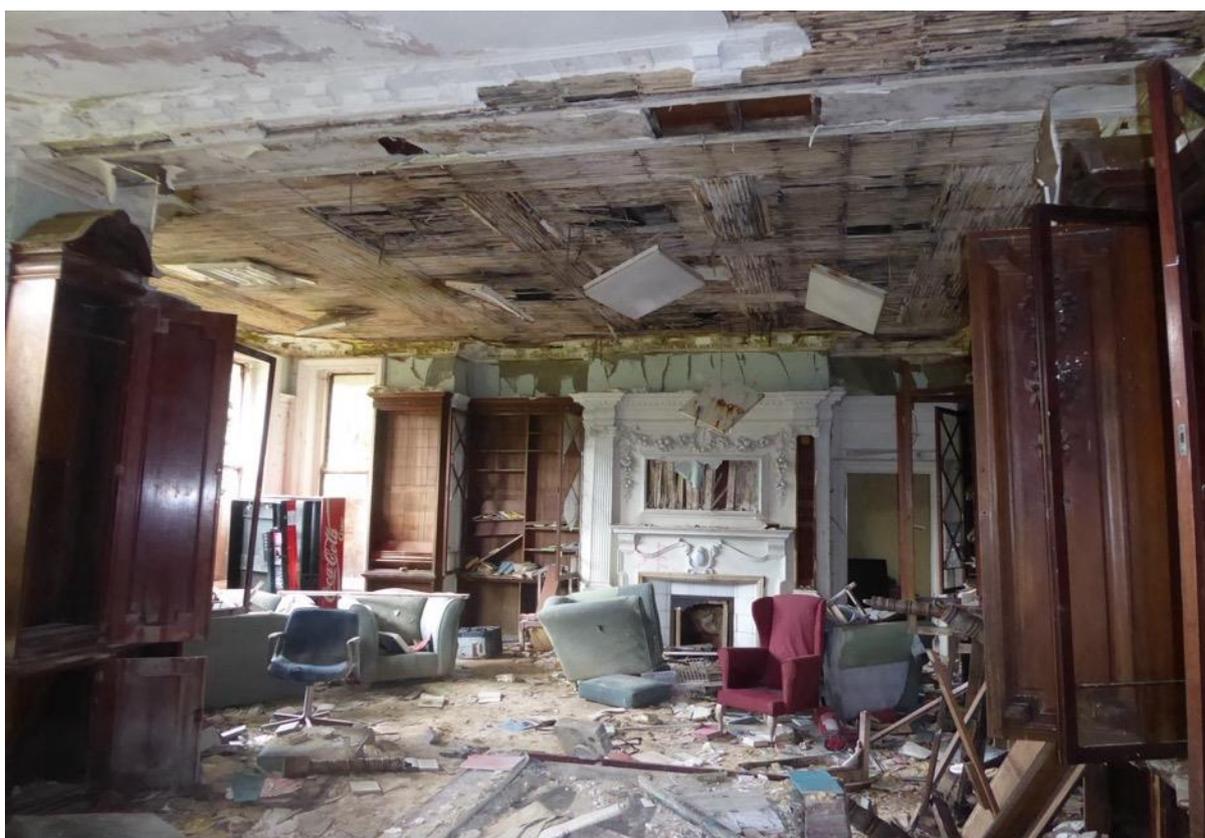
**Figure 11:** Typical internal finishes and condition of principal rooms to main house

- 5.5 The internal fixtures and finishes to the house are surprisingly intact in much of the 'main' house with principal rooms generally retaining a high degree of decorative finishes which include; fireplaces (**Figure 11 Appendix D**) plasterwork and panelling (**Figure 12 Appendix D**). The survival of the principal stair is particularly notable (**Figure 13 Appendix D**).

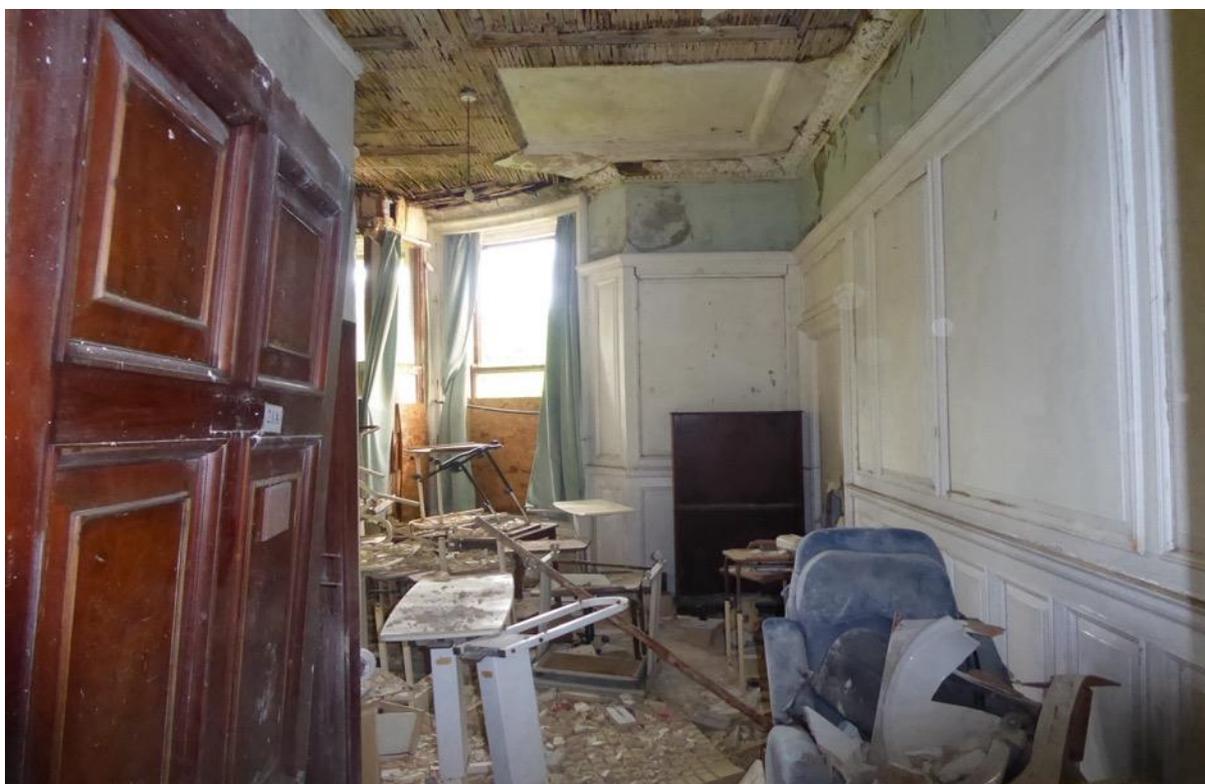
**Figure 12:** Plasterwork and panelling surviving albeit in a very poor condition

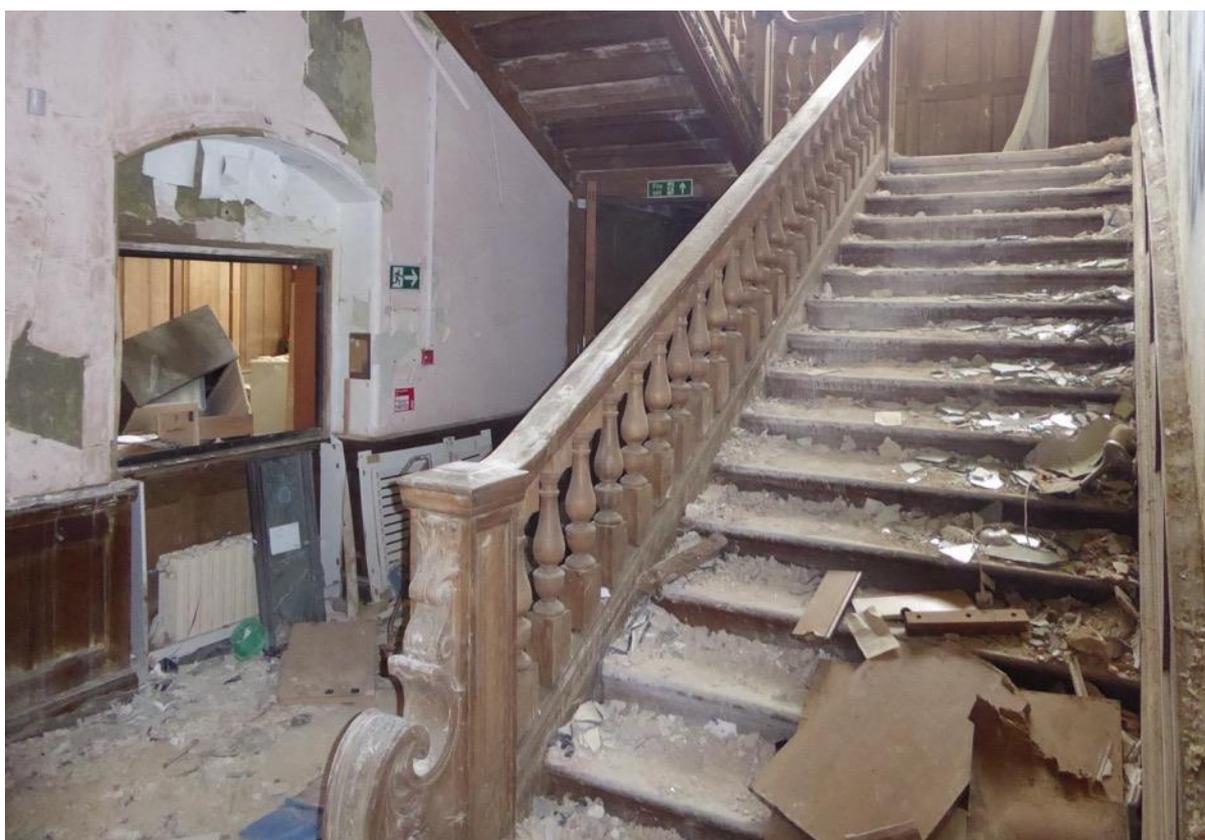
**Figure 13:** Principal stair ground to first floor

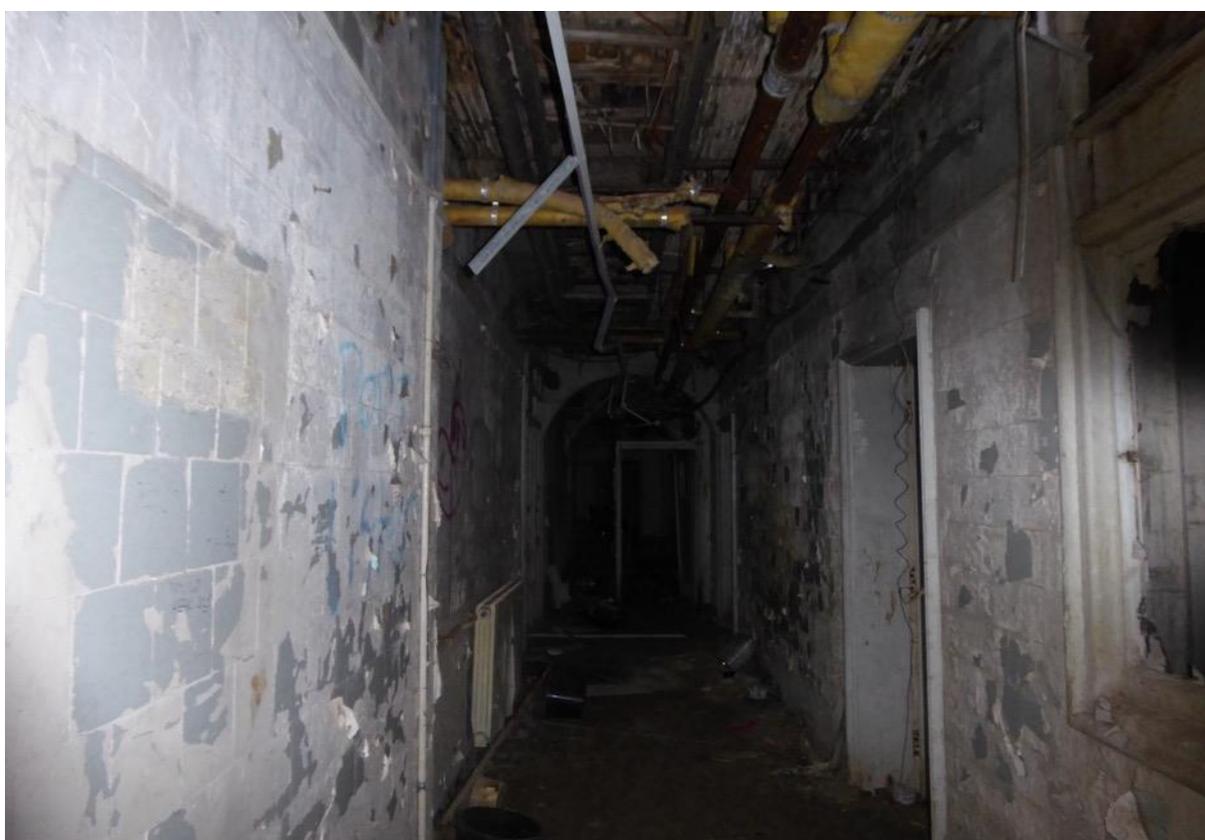
**Figure 14:** Lower ground (basement) 190406 main house- central corridor looking west

- 5.6 The lower ground floor is of a single c1904-6 build to the main house (**Figure 14 Appendix D**) and linked through to the semi-basement (**Figure 15 Appendix D**) of the remaining wings. There is no evidence of an earlier building to either the 1904-6 basement area or the 18<sup>th</sup> century wing semi-basement area. It is very difficult to see how any of the fabric of an earlier building would have been incorporated successfully into the present plan and there is no physical or visual evidence for this. We suspect this fabric was lost in the fire or post-fire clearance of the site.

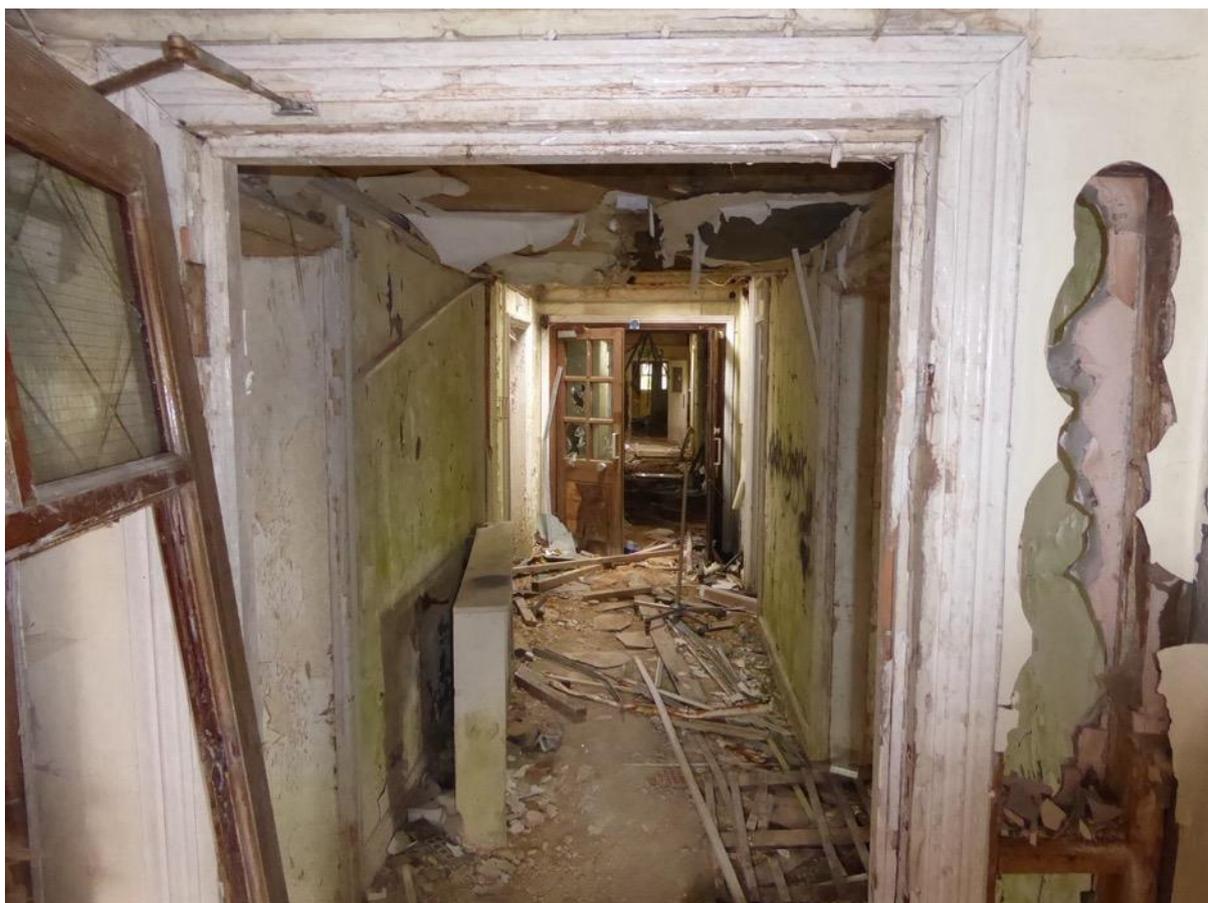
**Figure 15:** Lower ground (basement) looking east through late 18<sup>th</sup> century wing

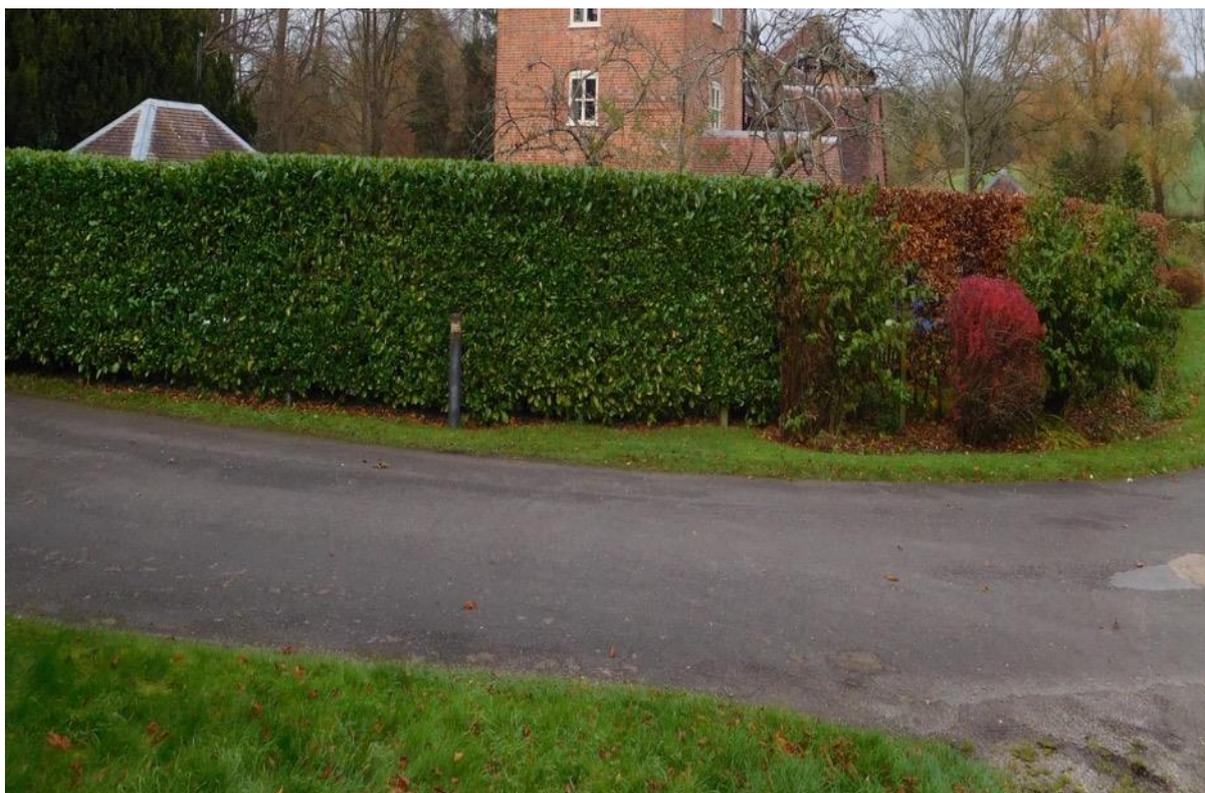
**Figure 17:** Former Stables and coach houses to the north of Westbury House – south and part east elevation

- 6.11 The stables to Westbury House (**Figure 17 Appendix D**) lie to the north-east of the house, adjacent to the entrance drive. They were added to the National Heritage List for England in 1954. The list description and Pevsner place the stables and coach houses in the 18<sup>th</sup> century built to service the previous mansion destroyed by fire and replaced in 1904-6. The stables and coach houses are consistent in plan with that shown on the Bridgeman plan. Since their addition to the list, the buildings have been converted to two dwellings, Richmond House and Cavendish House.

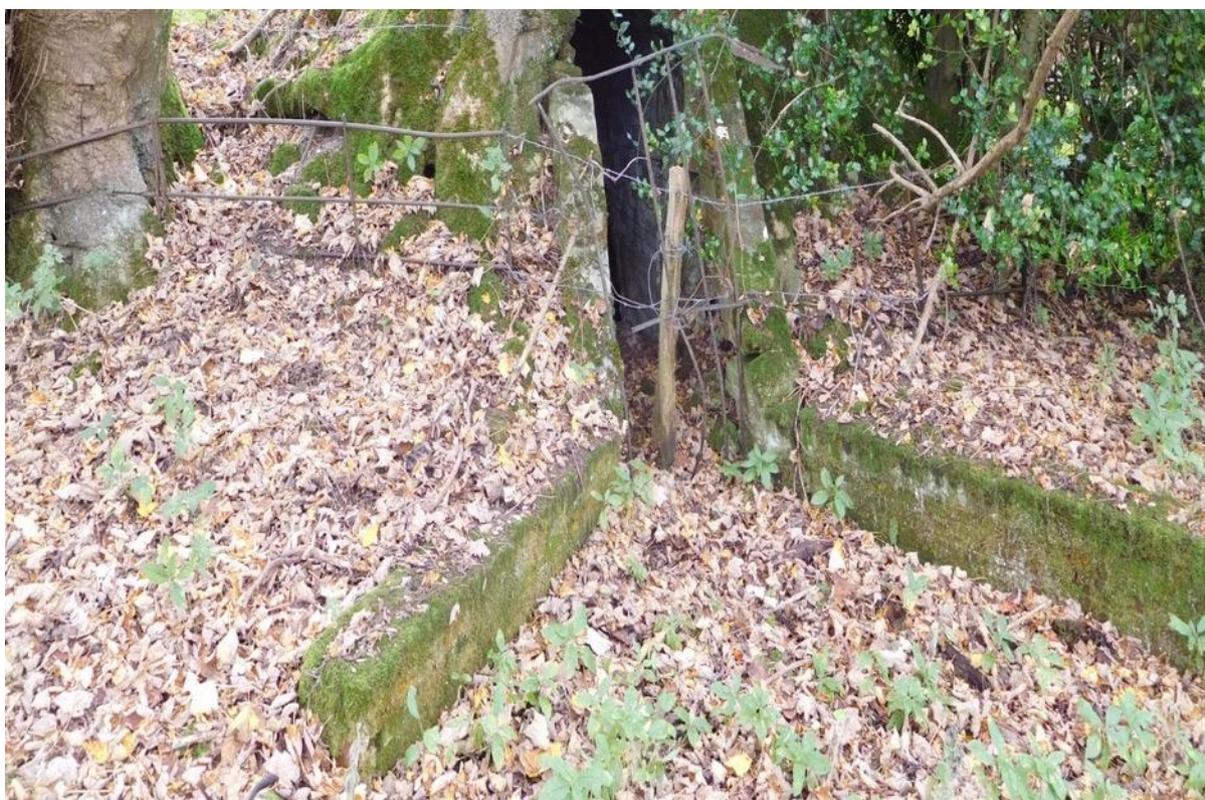
**Figure 20:** The roots of mature trees are beginning to significantly impact on the structure of the ice houses
